**SUZUKI MOTOR OF AMERICA, INC.**

October 18, 2013

The reported defect involves the front brake master cylinder. The name and address of the front brake master cylinder supplier is:

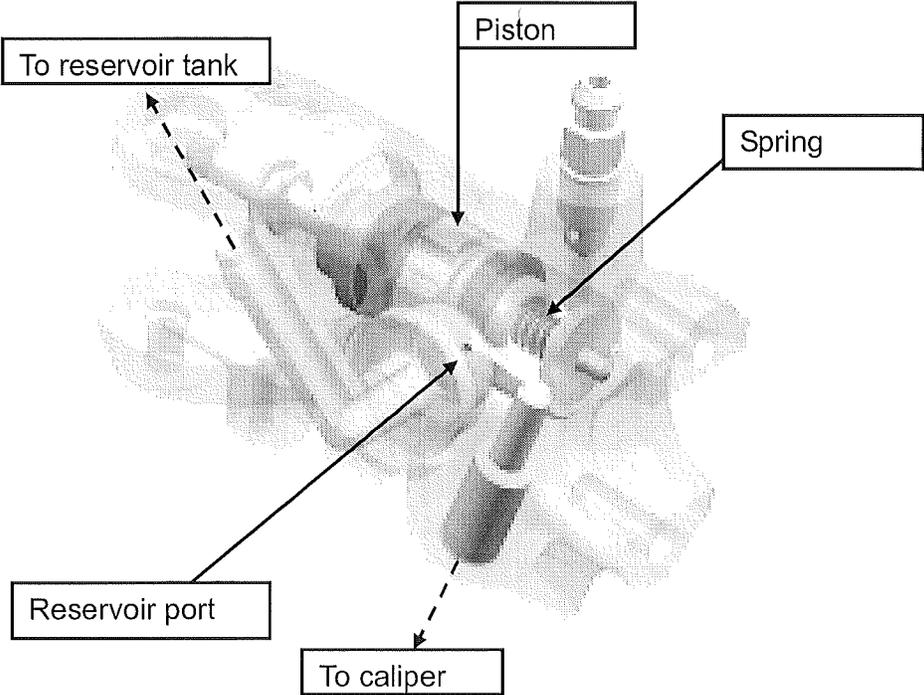
Front Brake Master Cylinder

After a long-term service life of the motorcycle without changing the brake fluid, the brake fluid can deteriorate and absorb moisture. The brake piston inside the front brake master cylinder of some motorcycles may not have uniform surface treatment. This combination of conditions can lead to corrosion of the brake piston. Corrosion of the brake piston generates gas, which may not be adequately purged from the master cylinder due to the side position location of the reservoir port. Gas remaining in the master cylinder can affect braking power by reducing proper fluid pressure transmission to the front brake. Over time, as gas continues to slowly accumulate above the reservoir port, the front brake lever may develop a “spongy” feel and stopping distances may be extended, increasing the risk of a crash.

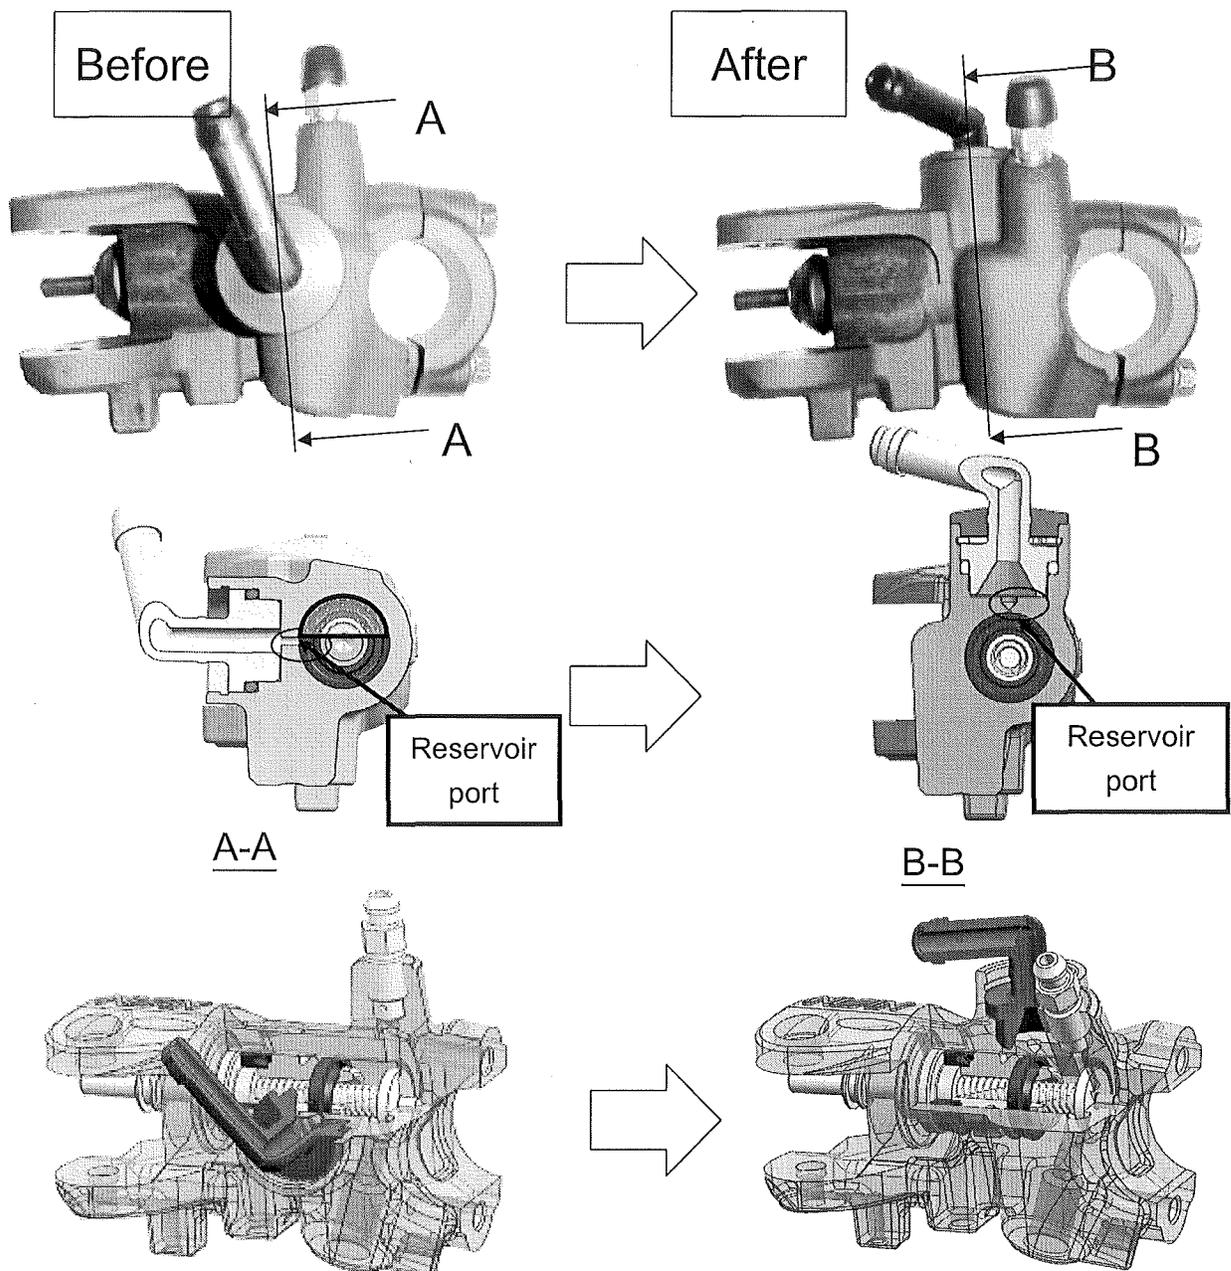
The reservoir port is located at the side position of the master cylinder. Gases are not purged sufficiently.

Suzuki distributors will conduct a safety-related recall campaign to replace the front brake master cylinder on affected motorcycles with a redesigned part that has the reservoir port at the top location of the master cylinder to allow better purging of gas, and has improved surface treatment for the brake piston. Several associated parts will also be replaced. SMAI currently anticipates that it will notify dealers about the details of the recall during the week of October 28, 2013, and will notify owners about the recall during the week of November 4, 2013. We expect that the Suzuki distributors in Hawaii and Puerto Rico will follow a similar schedule.

The reservoir port is located at the top position of the master cylinder to allow better purging of gases.
