**SUZUKI MOTOR OF AMERICA, INC.**

October 18, 2013

The reported defect involves the front brake master cylinder. The name and address of the front brake master cylinder supplier is:

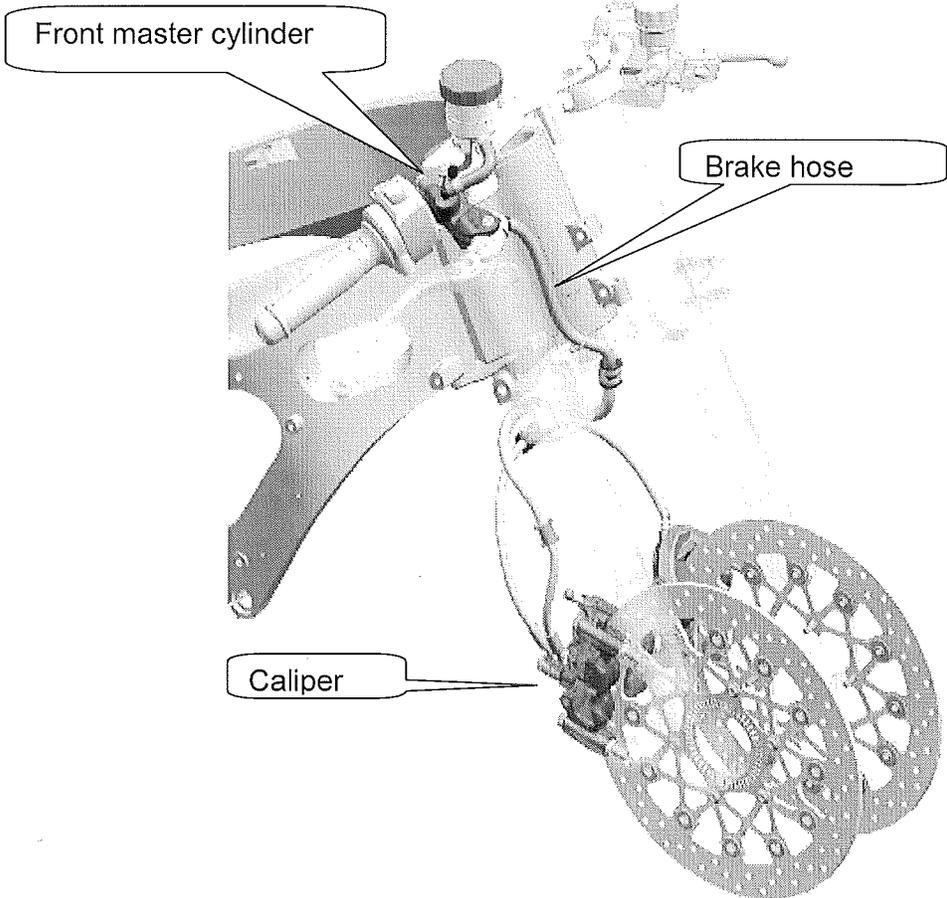
Front Brake System

After a long-term service life of the motorcycle without changing the brake fluid, the brake fluid can deteriorate and absorb moisture. The brake piston inside the front brake master cylinder of some motorcycles may not have uniform surface treatment. This combination of conditions can lead to corrosion of the brake piston. Corrosion of the brake piston generates gas, which may not be adequately purged from the master cylinder due to the side position location of the reservoir port. Gas remaining in the master cylinder can affect braking power by reducing proper fluid pressure transmission to the front brake. Over time, as gas continues to slowly accumulate above the reservoir port, the front brake lever may develop a “spongy” feel and stopping distances may be extended, increasing the risk of a crash.

Suzuki distributors will conduct a safety-related recall campaign to replace the front brake master cylinder on affected motorcycles with a redesigned part that has the reservoir port at the top location of the master cylinder to allow better purging of gas, and has improved surface treatment for the brake piston. Several associated parts will also be replaced. SMAI currently anticipates that it will notify dealers about the details of the recall during the week of October 28, 2013, and will notify owners about the recall during the week of November 4, 2013. We expect that the Suzuki distributors in Hawaii and Puerto Rico will follow a similar schedule.
